ROAD SAFETY AUDIT

Centre Street (Route 123) at Plymouth Street

Municipality of Brockton

November, 2017

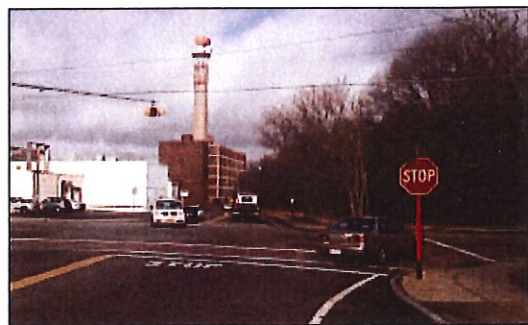
Safety Issue: Lack of Sight Distance Due to Vegetation and Parked Vehicles

Sight distance for vehicles approaching the intersection on Plymouth Street from the north as well as from the south is obscured by the presence of vegetation along the east side of the intersection parallel to Trout Brook and Plymouth Street. In addition, vehicles on the Plymouth Street northbound approaches have sight blocked due to parked cars along the west side of Plymouth Street and the south side of Centre Street (Route 123).

Vegetation to the right of the photo (northeast corner) obscures sight distances for vehicles waiting at stop line on the southbound approach

Enhancements: Trim back the vegetation on the northeast and southeast corners of the intersection to improve sight lines and consider prohibiting parking by posting “No

Parking” signs (R7-1) on Plymouth Street west side south of the intersection and on Centre Street (Route 123) south side west of the intersection far enough back to prevent sight blockage.

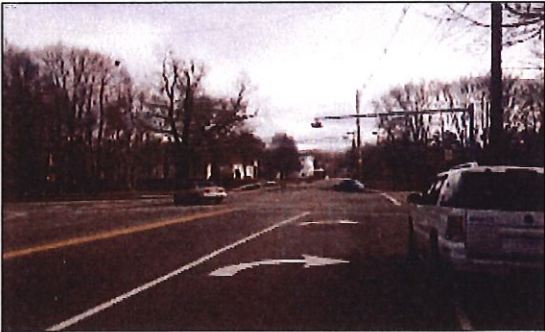
Safety Issue: Vehicle parking too close to the intersection

Vehicles park on Centre Street (Route 123) along the south side of the street on the eastbound approach (in front of the housing complex) right up to the intersection. In addition, vehicles are parked too close to the intersection on Plymouth Street along the west side of the street (in front of the housing complex). The right turn radii is hindered for buses, heavy vehicles, and right turning traffic (Centre Street eastbound to Plymouth Street southbound) due to these parked cars and parking maneuvers along the west side of Plymouth Street and the south side of Centre Street (Route 123) hinder moving traffic. The parking enforcement is not done on a regular basis, and the posted time limit for parking is only posted in one location (across the street from the BAT Parking Garage). In addition, these parked cars close to the intersection hinder the sight distance for Plymouth Street northbound vehicles looking west.

Vehicle parked too close to the intersection on the eastbound Centre Street (Route 123) approach.

Enhancements: Limit parking and post No Parking on Plymouth Street west side south of the intersection and on Centre Street (Route 123) south side west of the intersection far enough back to prevent sight blockage. Parking along the south side of Centre Street (Route 123) west of the intersection and parking along Plymouth Street on the west side south of the intersection, should be limited to permit parking for residents in the housing complex.

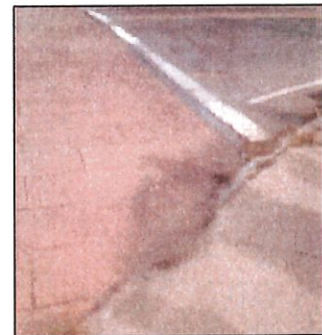
Safety Issue: Drainage Issues and Catch Basin Locations

A catch basin is located in the crosswalk at the southwest corner of the intersection. In addition, there are signs of ponding at the base of the curb ramp.

Signs of ponding on the crosswalk

Enhancement: Evaluate existing drainage conditions and relocate the catch basin that is within the crosswalks and other catch basins if necessary to improve drainage.
