Walk Assessment Brockton, MA

October 21, 2014

Massachusetts Department of Transportation
Bicycle and Pedestrian Safety Program

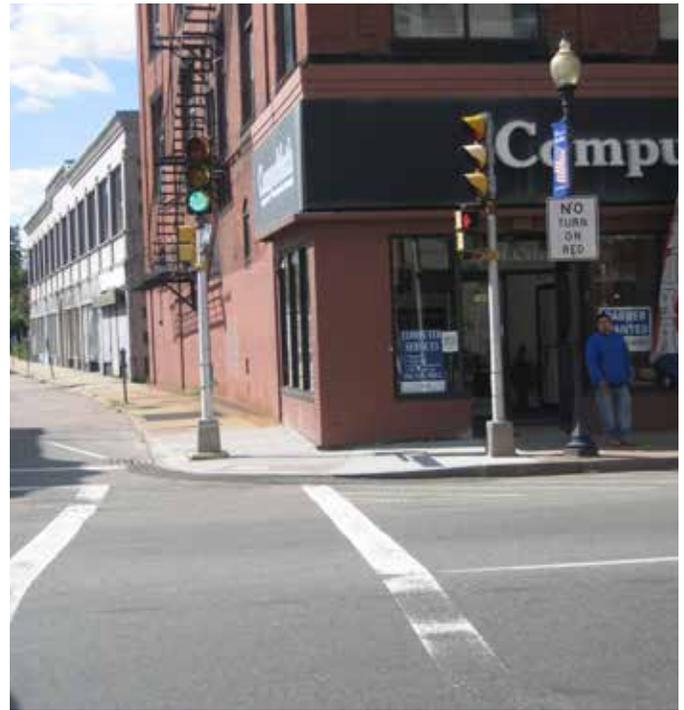
The pedestrian signal head is not lined up with the crosswalk entrance on N Main Street

- Pedestrian signal indication is not lined up with crosswalk entrance; adjacent to crosswalk, but easy to miss
- Exclusive pedestrian phase on traffic signal; wait time seems long given one-way traffic pattern; not a countdown signal
- Crosswalk pavement markings were minimal; may be temporary given that construction project is still underway
- Travel lanes are wide and crossing distances are relatively long

- Determine if pedestrian signal head could be rotated or moved to pole visible at crosswalk entrance
- Evaluate signal phasing to determine if a concurrent phase is possible and if the pedestrian crossing time is sufficient. Before switching to a concurrent phase, evaluate the red light running frequency, clearance and change interval, and crash data to be sure motorists typically comply with the existing signal. Add leading pedestrian indicator (LPI) with concurrent phase, if appropriate
- Enhance pavement markings with a ladder design, or stamped colored asphalt

- Install curb bump-outs to better define parking zones, narrow travel lanes and shorten crossing distances; long-term fix given recent curb ramp upgrades

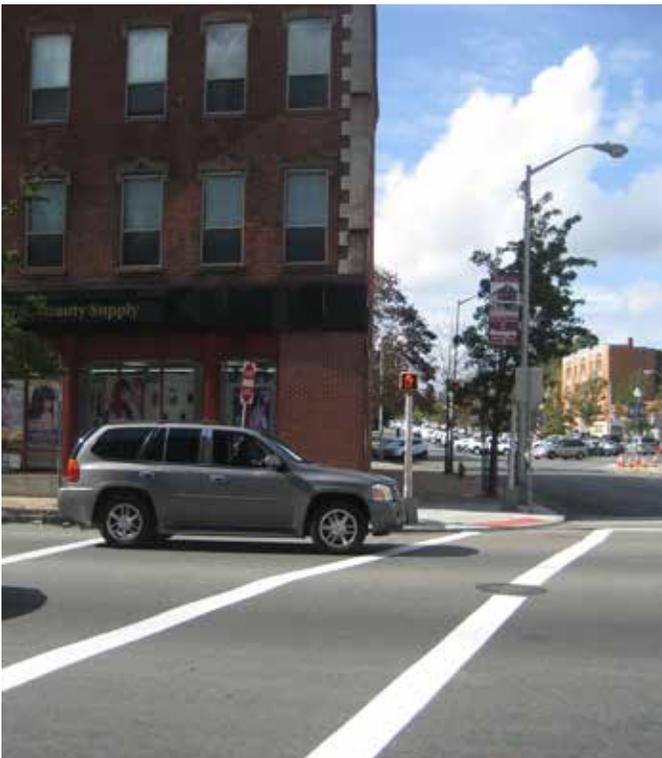
- Multiple pedestrian push buttons and traffic control equipment on the east side of Main Street intersection; the older of the two pedestrian push buttons continues to control pedestrian phase; could be due to construction in progress
- Crossing time is not sufficient when crossing Legion Parkway, unless intersection is timed as a 2-phase crossing; if 2-phase crossing, there is no pedestrian push button in the median
- Median in Legion Parkway is being used as a pedestrian refuge island, but does not provide adequate protection

- Pedestrian traffic signal is not a countdown signal
- Crosswalk pavement markings are minimal; may be temporary given that construction project is still underway
- Travel lanes are wide and crossing distances are relatively long; particularly across Legion Parkway

There are two pedestrian push buttons at this location; only one of which controls the signal

- Remove one of the two pedestrian push-button to eliminate confusion around which button controls the signal
- Evaluate signal phasing to determine if a concurrent phase is possible and if the pedestrian crossing time is sufficient, particularly across Legion Parkway. Pedestrians cross the entire width of Legion Parkway in one phase and the crossing time should reflect this practice. Before switching to a concurrent phase, evaluate the red light running frequency, clearance and change interval, and crash data to be sure motorists typically comply with the existing signal. Add leading pedestrian indicator (LPI) with concurrent phase, if appropriate

- Redesign median to work as a pedestrian refuge island to protect pedestrians who get stuck in roadway; install pedestrian push button to facilitate a protected crossing from the island

- Install pedestrian countdown signal
- Enhance pavement markings with a ladder design, or stamped colored asphalt
- Install curb bump-outs to better define parking zones and bus stops, narrow travel lanes and shorten crossing distances

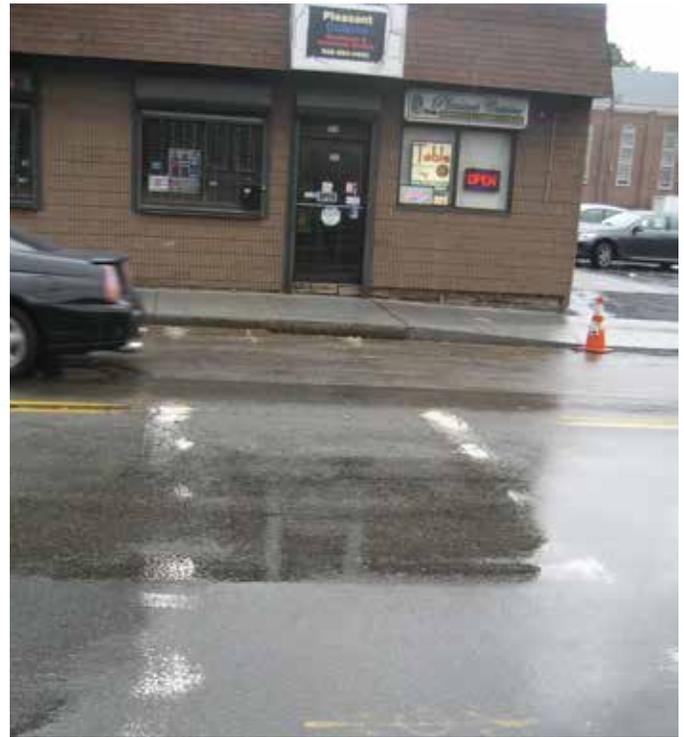
Unprotected mid-block crossing on Pleasant Street

- Mid-block crossing in front of the Mt. Moriah Baptist Church has no curb ramps, detectable warning strips, or pedestrian crossing signage
- Only one marked crossing on Pleasant Street between Main and Warren
- Crosswalks at intersections and mid-block are faded

- Evaluate the safety of the mid-block crossing at the Baptist Church; if appropriate, install ADA-compliant curb ramps, detectable warning strips, and pedestrian crossing signage
- Consider another marked crossing on Pleasant Street; both to provide another recognized crossing point for pedestrians and to increase driver awareness of operating speeds by providing more “visual friction” along the roadway. Visual friction includes signage, landscape elements or other horizontal or vertical features in the roadway that encourage drivers to check their speeds
- Re-stripe crosswalks

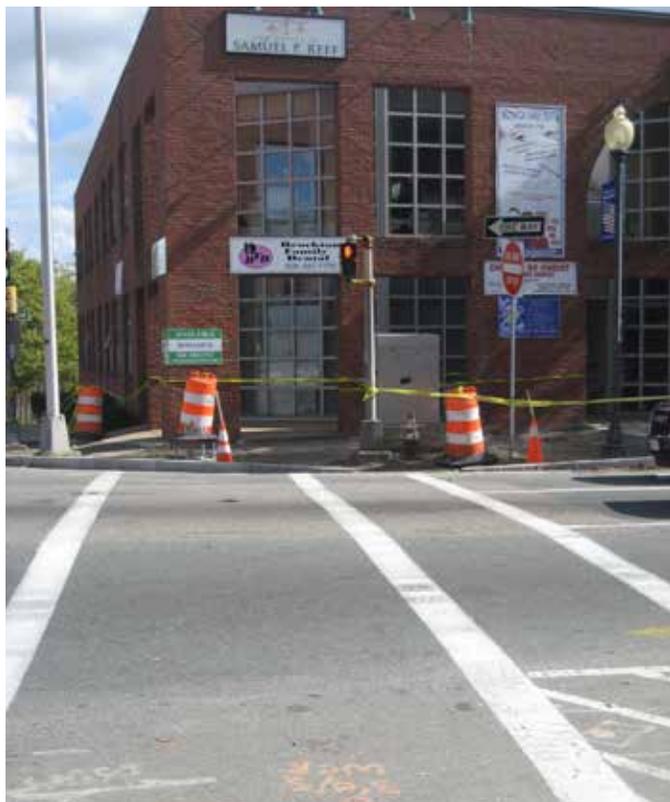
- No accommodations for pedestrians during sidewalk construction; forced into the street at the intersection
- Travel lanes seem wide
- Parking is sporadic and undifferentiated
- Crosswalks are minimal
- Signal phasing is exclusive for pedestrians

Lack of pedestrian accommodations during construction at the intersection of Main Street and Pleasant Street

- Enforce a requirement to provide accommodations for pedestrians during sidewalk construction on all projects within the City of Brockton
- Delineate travel lane (10.5’-11’) on Pleasant Street with an edge line; current edge line provides for wider travel lane
- Regularize and delineate parking zones on Pleasant Street
- Enhance pavement markings with a ladder design, or stamped colored asphalt
- Evaluate signal phasing to determine if a concurrent phase is possible and if the pedestrian crossing time is sufficient. Before switching to a concurrent phase, evaluate the red light running frequency, clearance and change interval, and crash data to be sure motorists typically comply with the existing signal. Add leading pedestrian indicator (LPI) with concurrent phase, if appropriate

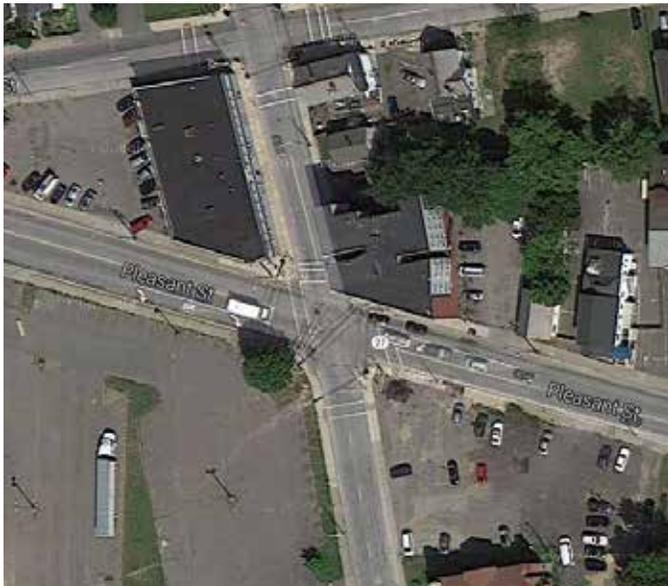
This intersection is irregular as Warren Avenue crosses Pleasant Street at an angle. The angles create long crossing distances across Pleasant Street and complicate the location of a crosswalk in relationship to the traffic signal. The sidewalks, curb ramps and traffic signals at and near the Pleasant/Warren intersection were replaced in the summer of 2014 – within the timeframe of this assessment. The final pavement markings were not yet in place at the time of the assessment.

The intersection geometries were not changed during the sidewalk replacement project, but the location of the curb ramps did change. The ramps were moved away from the intersection and placed on the tangent to the curve along each curb. These locations shorten crossing distances and provide a straight path from one sidewalk to the next. However, the crosswalks and ramps are outside pedestrian desire lines; in some cases, the crosswalk is back so far from the intersection that pedestrians may not walk within the crosswalk and cars may stop beyond the stop line and block the crossing.

Pleasant Street and Warren Street intersection geometry creates complicated crossing issues

- Crosswalks and curb ramps are outside pedestrian desire lines
- No countdown pedestrian traffic signals
- Traffic signal is exclusive for pedestrians despite one-way traffic on Warren Street
- Grocery store is a major change in land use and will alter pedestrian patterns

- Re-evaluate curb ramp and crosswalk locations to maximize pedestrian compliance with traffic signals while meeting ADA requirements
- Replace pedestrian traffic signal equipment with countdown signals. Evaluate signal phasing to determine if a concurrent phase is possible and if the pedestrian crossing time is sufficient. Before switching to a concurrent phase, evaluate the red light running frequency, clearance and change interval, and crash data to be sure motorists typically comply with the existing signal. Add leading pedestrian indicator (LPI) with concurrent phase, if appropriate
- Evaluate bus stop locations in conjunction with grocery store site plan and coordinate pathways to the store with bus stops to serve public transit users
- Study the pedestrian patterns around the new grocery store once completed, and alter the pathways to improve pedestrian safety, if needed

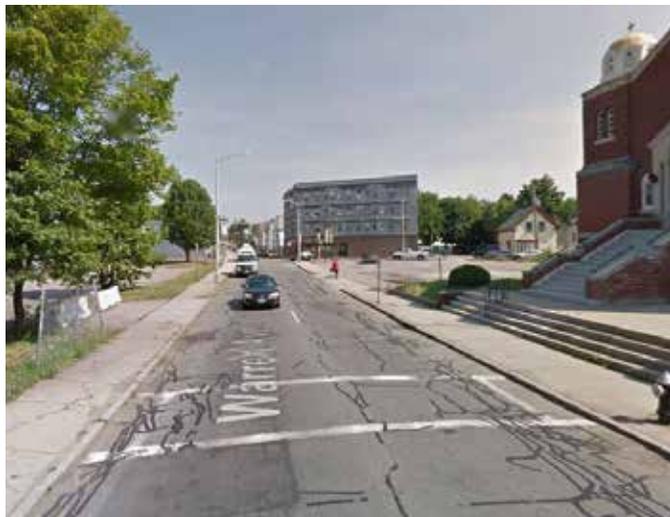
- Mid-block crosswalk has no curb ramps, pedestrian crossing signs or tactile warning panels
- Sidewalks are poorly maintained; vegetation is overgrown

Mid-block crosswalk on Warren Street may not be in the appropriate location

- Evaluate the current location of the mid-block crosswalk in conjunction with the planned grocery store site plan. If appropriately located, install curb ramps, pedestrian signage, and tactile warning strips to make this crossing ADA compliant
- Upgrade sidewalks on both sides of Warren Avenue to promote walking to the new grocery store
- Work with the service station owners to reduce the width of the curb cuts to improve sidewalk network

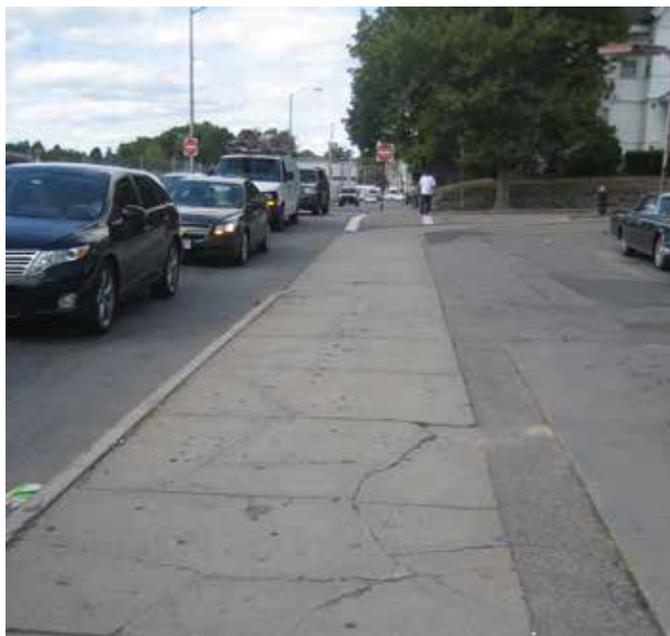
- Service stations on both sides of the Green Street intersection have extensive curb cuts which compromise the safety of the sidewalks

Wide curb cuts along Warren Street compromise sidewalks

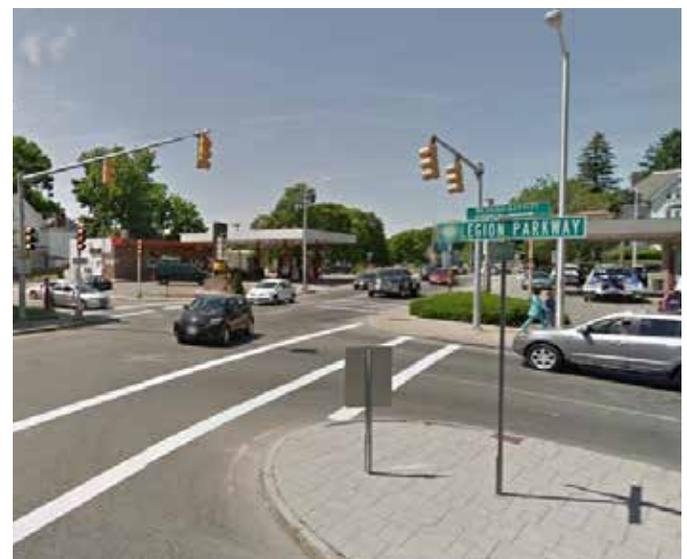
- No protected crossing for pedestrians in any direction at the Warren Ave/Legion Pkwy intersection; no pedestrian signal heads and no pedestrian phase
- Long crossing distances particularly across the Legion Parkway – the equivalent of six lanes of traffic
- Limited lane definition on both eastbound and westbound lanes on Legion Parkway; promotes faster turning movements and allows drivers to interpret the number of acceptable travel lanes
- The northeast and southeast corners of Legion Parkway are occupied by service stations with wide curb cuts, which compromise the pedestrian zone. Pedestrians must watch for oncoming traffic, turning traffic and motorists leaving the service stations
- The median functions as a pedestrian refuge island, but was not designed for this purpose; the median is not ADA-compliant
- No tactile warning panels on the curb ramps

Legion Parkway and Warren Street intersection has no pedestrian crossing phase

- Upgrade traffic signal equipment and install pedestrian countdown signals. Include a pedestrian phase that is long enough to allow pedestrians to cross the entire distance across Legion Parkway
- Consider installing curb extensions across Legion Parkway to shorten the crossing distance
- Use pavement markings to improve lane definition and narrow wide travel lanes
- Work with the service station owners to reduce the width of the curb ramps to minimize the number of entrances pedestrians need to scrutinize before crossing the street
- Redesign median to function as an effective, ADA-compliant pedestrian refuge island
- Install tactile warning panels on all curb ramps

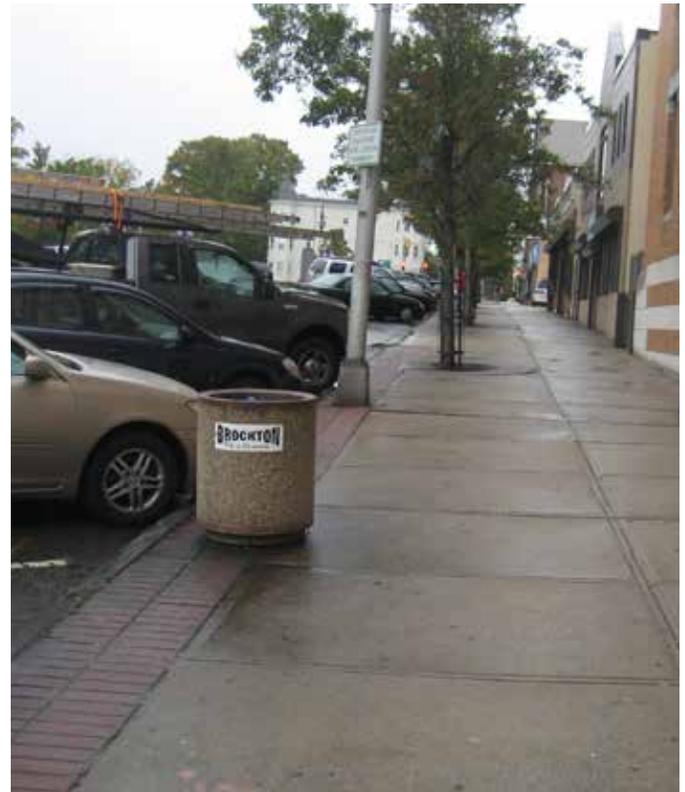
Wide sidewalk on Legion Parkway

Sidewalks along the storefronts are wide with an adequate walking zone. Street trees help to mitigate the otherwise automobile-dominated space. Once away from the storefronts, Legion only accommodates the needs of the car. Pedestrians cross at will from between cars parked along the median.

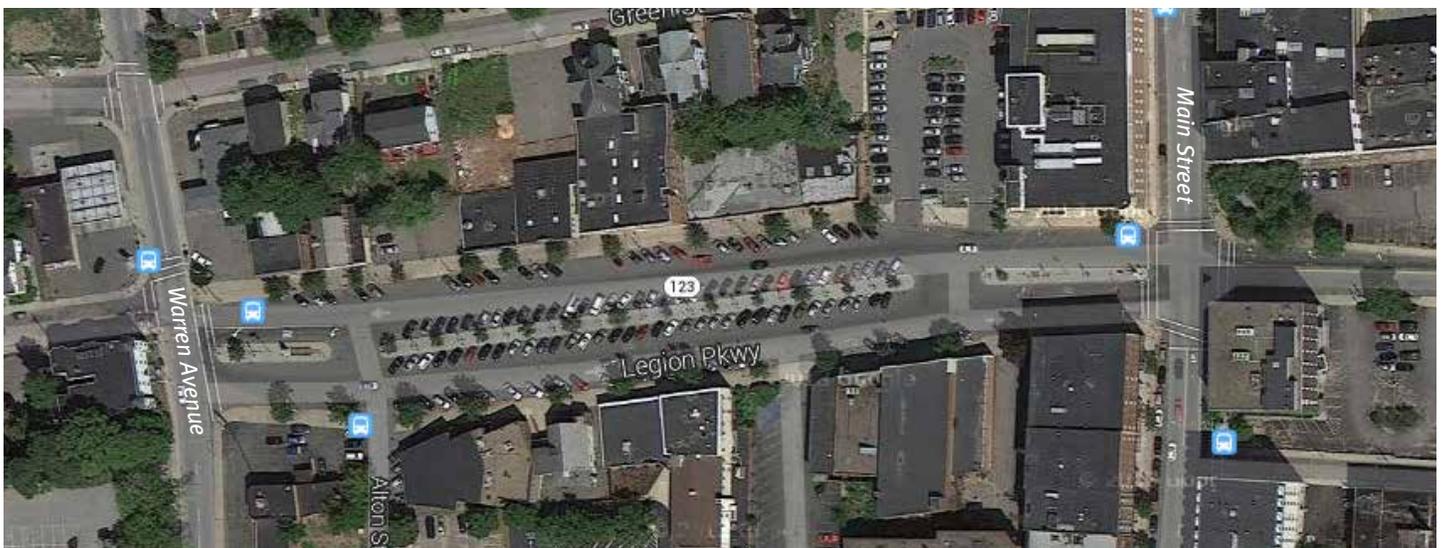
BAT has three bus stops on Legion providing access to eight bus routes. There is room for buses to pull out of travel lane to pick up and drop off passengers. One participant was almost clipped by a bus mirror as the bus pulled up to the curb.

Aerial view of Legion Parkway

- No marked crosswalks between Warren Avenue and Main Street
- Median is not accessible – no curb ramps; could be re-designed as a useable open space
- Travel lanes and bus stops could be better defined
- Angled parking layout causes drivers to back blindly into the roadway

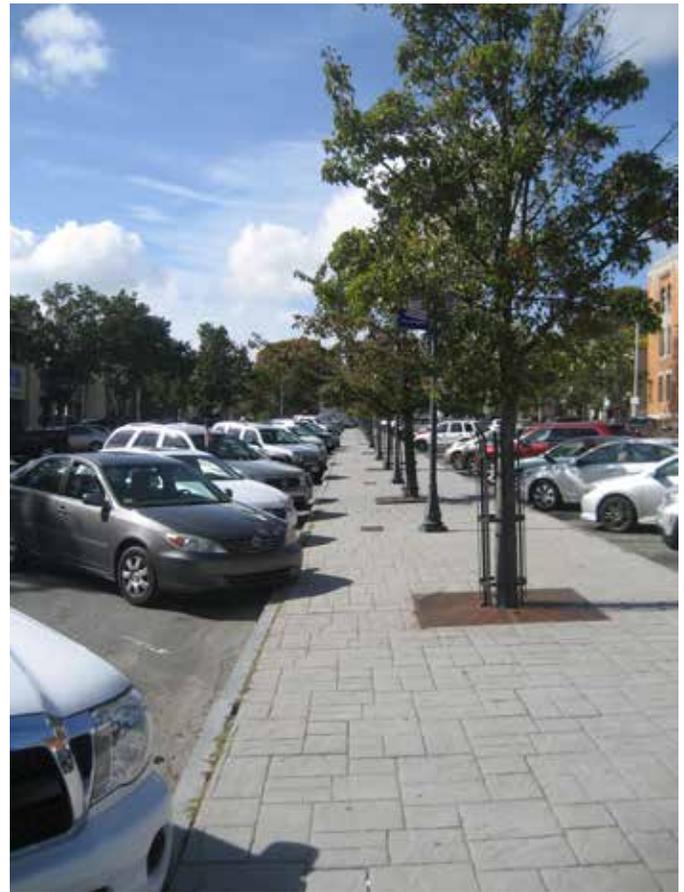
Wide median runs continuously down Legion Parkway between the two rows of angled parking. There may be an opportunity to rethink this space as a people-oriented gathering space.

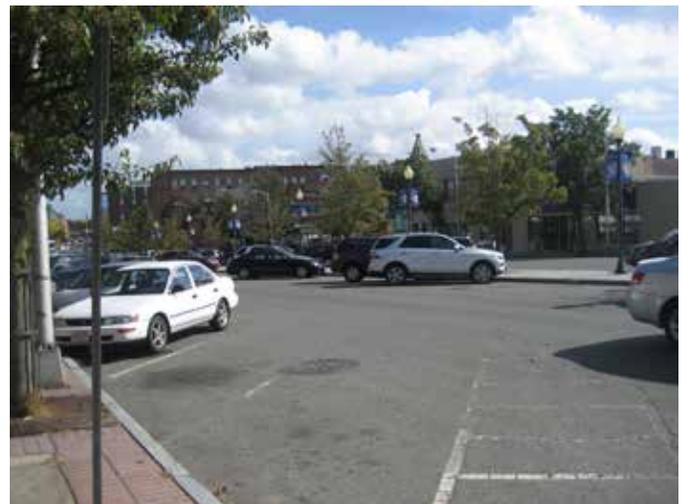
There are no marked crosswalks for the length of Legion Parkway. Pedestrians wait for a gap in traffic and cross from between parked cars to reach neighboring businesses.

- Evaluate locations for one or more pedestrian crosswalks across Legion Parkway based on land use and current pedestrian patterns and install permanent street crossings

- » Test different locations with temporary removal of parking spaces and delineation of crossing zones; use in-street pedestrian signs to bring awareness to the crossing area

- » Install permanent curb extensions and pavement markings at appropriate location(s); pavement markings could be enhanced crosswalks, such as a ladder design, or stamped asphalt

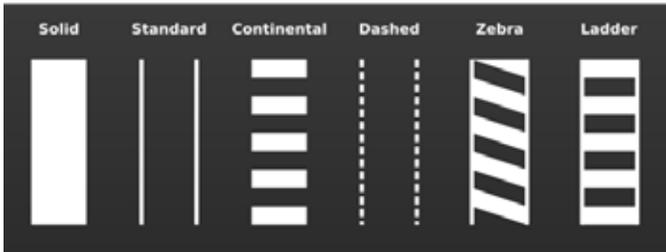
Crosswalks can be painted in a variety of ways, some of which are more effective in warning drivers of pedestrians. Crosswalks are usually accompanied with stop lines. These lines act as the legally mandated stopping point for vehicles, and discourage drivers from stopping in the middle of the crosswalk.

Crosswalk patterns
Source: USFHA

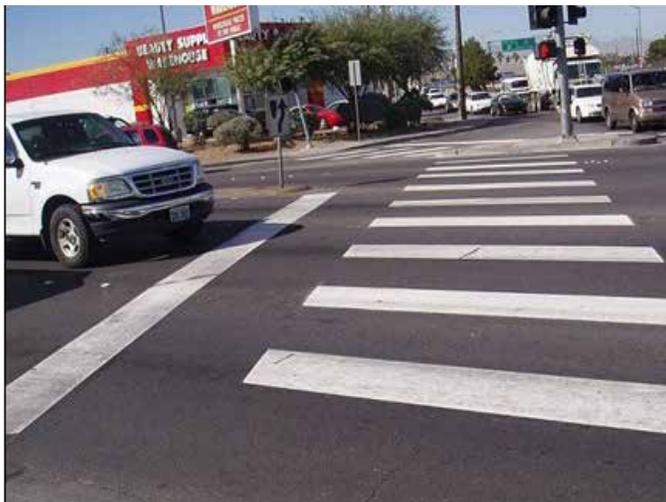
Crosswalk and stop line
Source: http://safety.fhwa.dot.gov/ped_bike/tools_solve/ped_scdproj/sys_impact_rpt/images/fig16.jpg

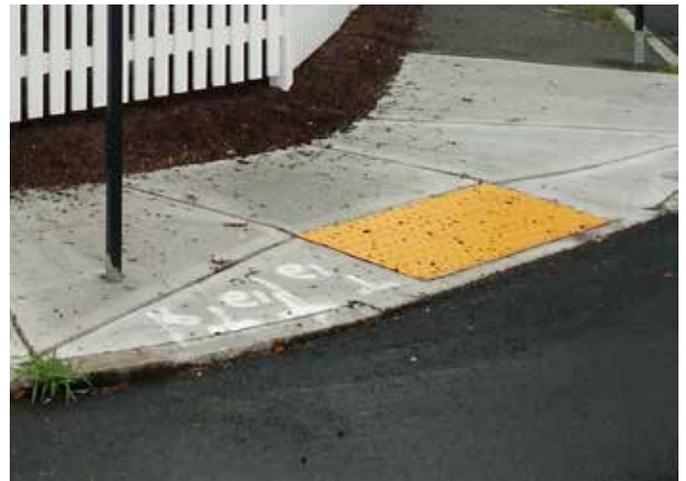
Curb ramps provide access from the sidewalk to the street for people using wheel chairs and strollers. They are most commonly found at intersections. While curb ramps have improved access for wheelchair-bound people, they are problematic for visually impaired people who use the curb as an indication of the side of the street. Detectable warning strips, a distinctive surface pattern of domes detectable by cane or underfoot, are now used to alert people with vision impairments of their approach to streets and hazardous drop-offs.

Curb ramp and detectable warning strip in Woburn, MA

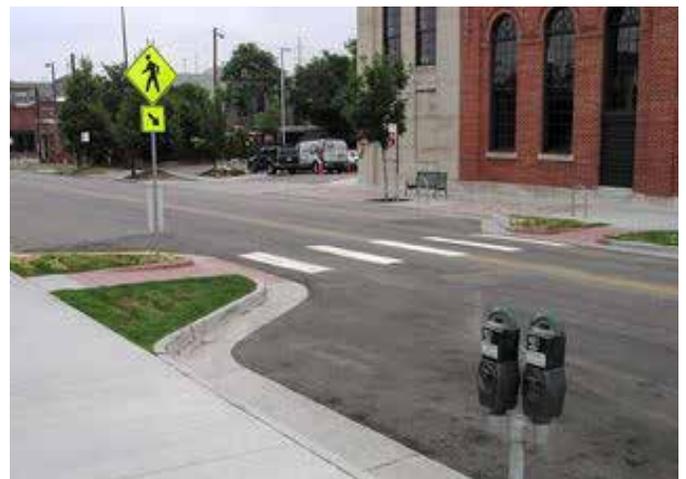
Curb extension/curb bulb-out

A sidewalk extension into the street (into the parking lane) shortens crossing distance, increases visibility for walkers and encourages eye contact between drivers and walkers.

Curb extensions are often associated with mid-block crossings

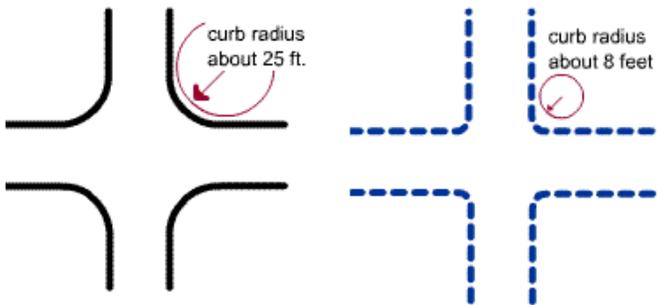
A longer curb radius (on the left in figure below) allows vehicles to turn more quickly and creates longer crossing distance for pedestrians. A shorter curb radius (on the right in the figure below) slows turning speeds and provides pedestrians shorter crossing distances.

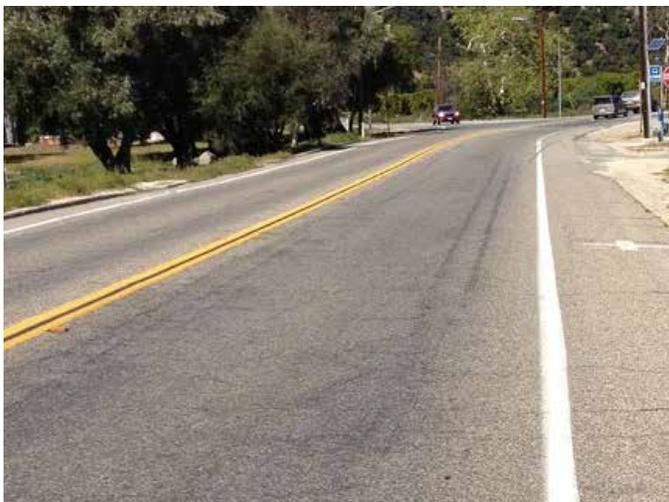
An edge line is a solid white line painted along the roadside curb that defines the driving lane and narrows the driver's perspective. Edge lines are most often used in suburban and rural locations, but may be appropriate in some urban conditions.

Edge lines delineate the vehicular driving zone on wide roadways.

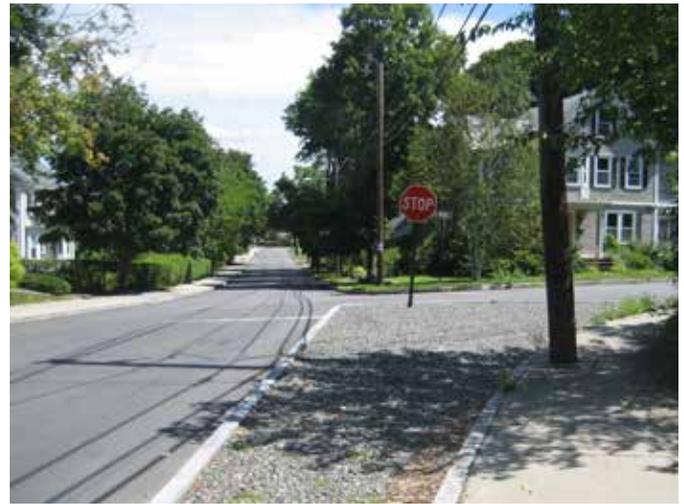
(A) Gravel-filled curb extension

There are two excellent examples of the shortening of curb radii in Woburn, MA. The first (A) is a low-cost solution using a gravel-filled zone between the original curb line and the newly established road edge. The second is a higher-cost solution using grass and trees and extending the sidewalks to the new curb. Both work to slow traffic.

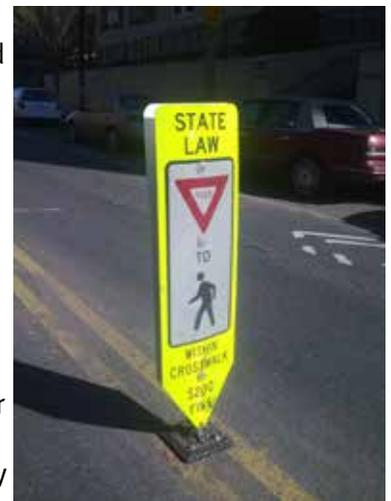
In-street pedestrian crossing sign

In-street pedestrian crossing signs are used at the road centerline within crosswalks to increase driver awareness of pedestrians in the area. These signs are a relatively low-cost, highly effective tool in slowing traffic by the narrowing travel lanes. They are popular with road maintenance departments since they can be easily moved for snow removal.

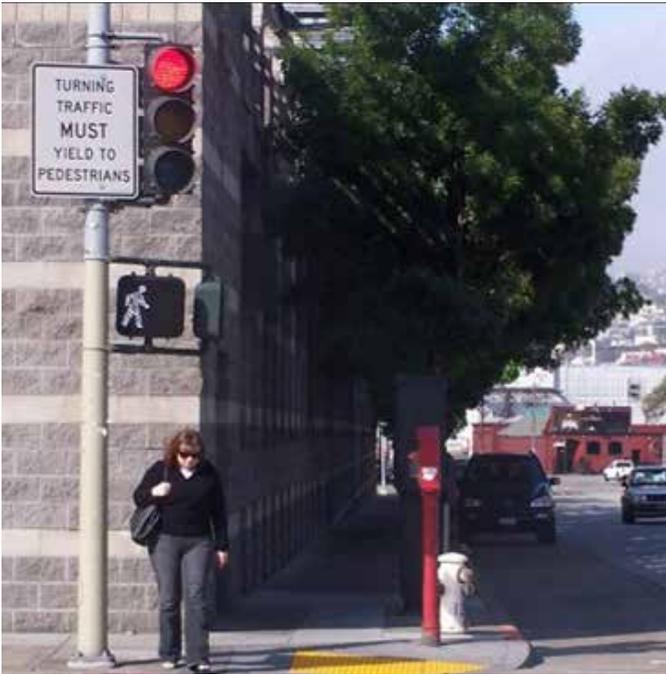
A leading pedestrian indicator gives pedestrians an advance walk signal before motorists get a green signal, giving the pedestrian several seconds to start walking in the crosswalk before a concurrent signal is provided to vehicles. This makes pedestrians more visible to motorists and motorists more likely to yield to them. Typical LPI settings provide 3 to 6 seconds of advance walk time.

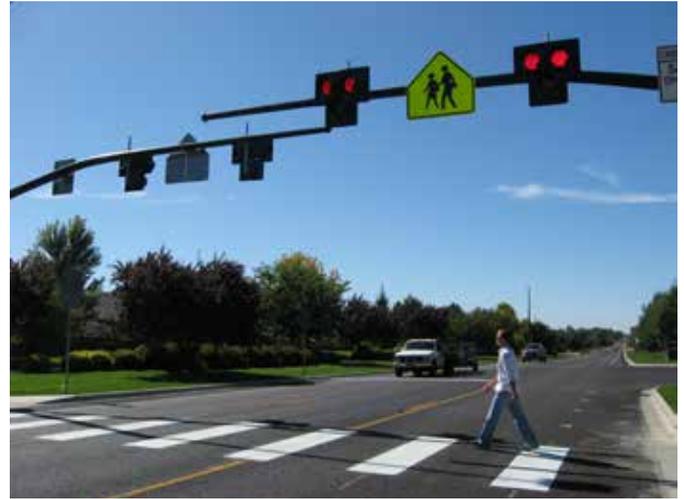
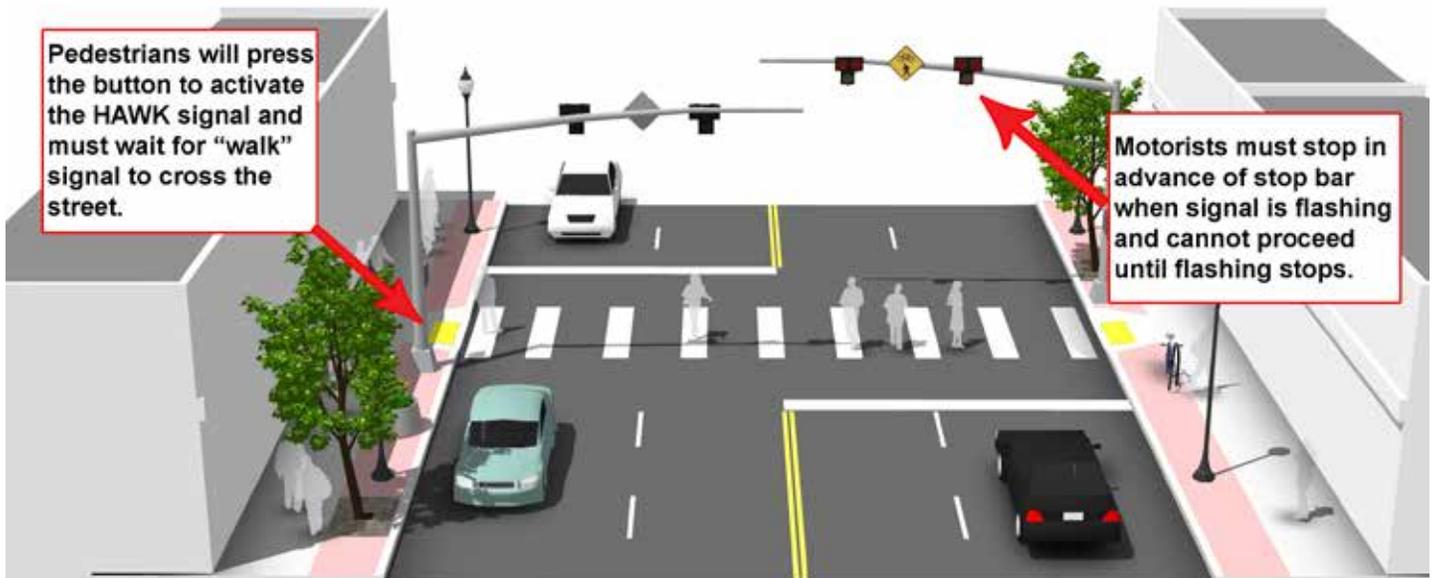
A HAWK beacon (High-Intensity Activated crossWalk beacon) is a traffic signal used to stop road traffic and allow pedestrians to cross safely. It is officially known as a Pedestrian Hybrid Beacon (PHB). The purpose of a HAWK beacon is to allow protected pedestrian crossings, stopping road traffic only as needed. Where standard traffic signal 'warrants' prevent the installation of standard three-color traffic signals, the HAWK beacon provides an alternative.

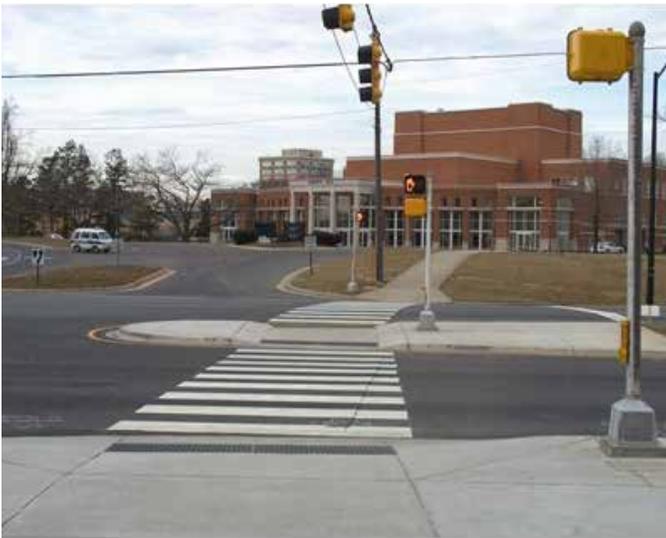
Pedestrian refuge islands are protected areas where people may safely pause or wait while crossing a street. Pedestrian refuge islands are particularly helpful as resting areas for seniors, persons with disabilities, children, and others who may be less able to cross the street in one stage. At signalized intersections, they allow slow moving pedestrians to cross in two phases. At unsignalized locations, they simplify the act of finding a gap in traffic to cross since vehicles from only one direction must be reckoned with at a time.

Pedestrian refuge island at a signalized crossing
