ROAD SAFETY AUDIT

Centre Street (Route 123) at Plymouth Street

Municipality of Brockton

November, 2017

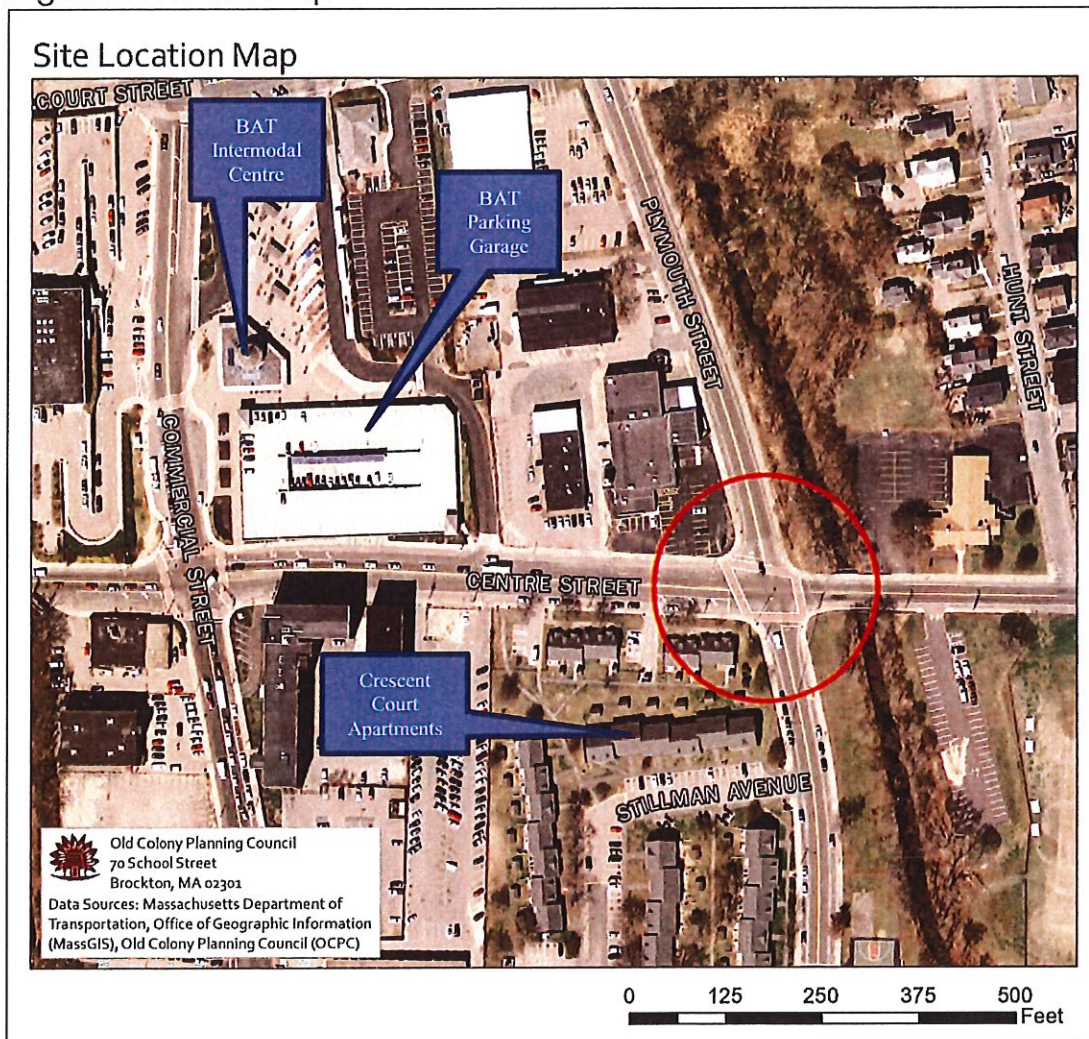
Figure 1: Locus Map

provides a shared through left turn lane and an exclusive right turn lane. This eastbound approach has a four lane cross-section and is approximately 65 feet in width, which presents a long, hazardous crossing for pedestrians. There are four twelve foot lanes plus two eight foot shoulders used for parking on Centre Street (Route 123) west of the intersection. Some motorists use the south side of the eastbound Centre Street approach for commuter rail parking. The time restrictions are posted across from the BAT Parking Garage near Commercial Street, but are not posted on Centre Street (Route 123) near the Centre Street (Route 123)/Plymouth Street intersection (near the Crescent Court Apartments). In addition, some motorists park on the west side of Plymouth Street (southbound direction), near the Crescent Court Apartments, south of the intersection, which also provides an eight foot shoulder. Figure 1 shows the location of the intersection.

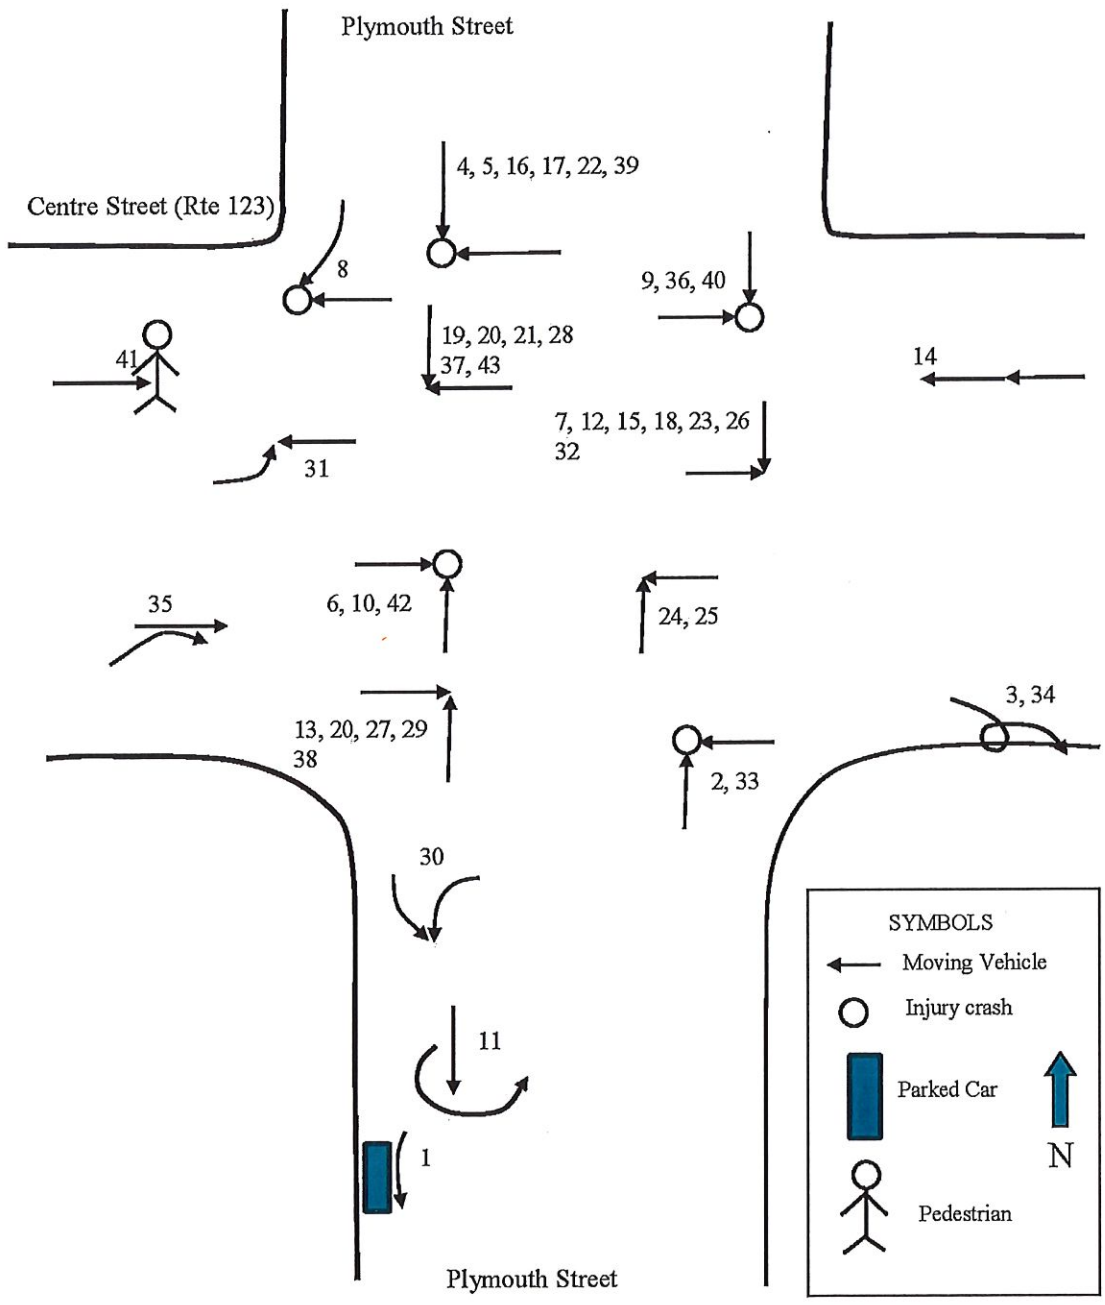
COLLISION DIAGRAM
 Centre Street (Route 123) at Plymouth Street
 Collision Diagram for Crashes (2014, 2015, 2016) Prepared by
 OCPC (RG 9/2017) (source: Brockton Police Dept.)

This intersection experiences a higher number of angle type crashes crash than is expected for a stop controlled four-way intersection. A large portion of these crashes occurred when the southbound vehicle on Plymouth Street failed to yield right of way to an eastbound vehicle or westbound vehicle on Centre Street (Route 123).
