MUNICIPAL AND SCHOOL FACILITIES STUDY AND MASTER PLAN

City of Brockton
Brockton, Massachusetts

Volume 1 — School Facilities Assessment

December 3, 2018

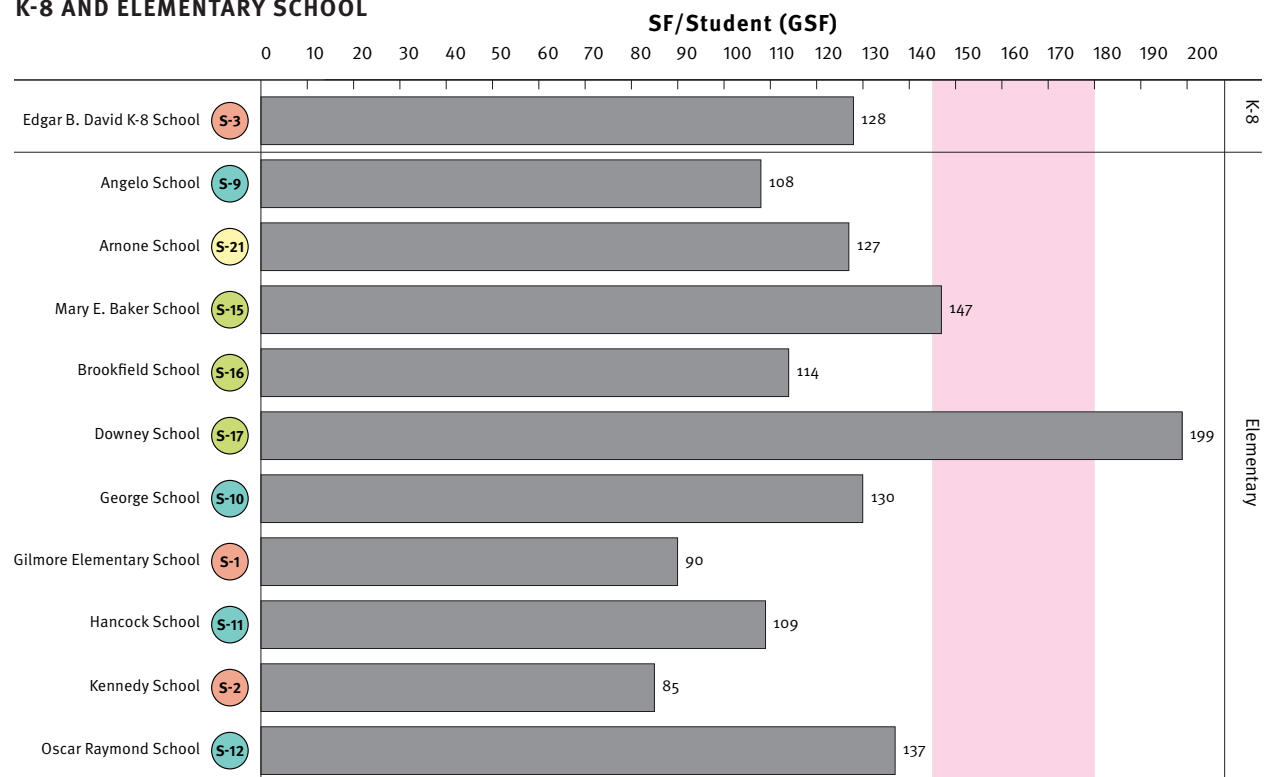
K-8 AND ELEMENTARY SCHOOL

The following demonstrates the existing SF/ Student, in comparison to the MSBA guideline range.

LEGEND Massachusetts School Building Authority (MSBA) K-8 Guideline Range (145–180 GSF per student)

The calculations used for determining the SF/Student were achieved by dividing the August 2017 enrollment per school (provided to the team by Brockton Public School) by the overall building gross square footage, including all parts of the permanent building and all temporary modular construction currently serving the facility. These results will be further analyzed in Volume 2— School Master Plan Recommendations, Section 2— Existing Space Analysis

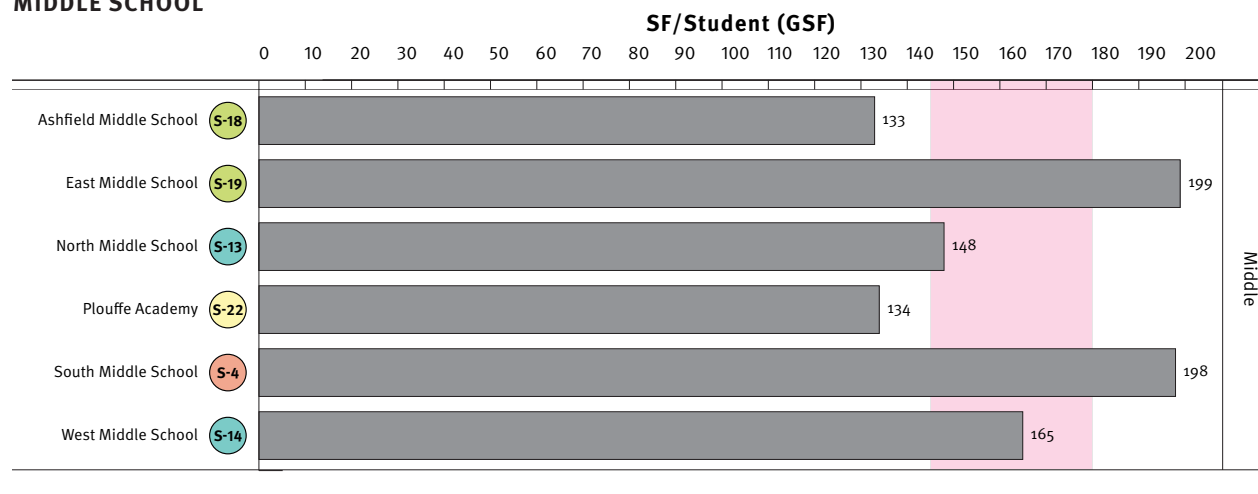
MIDDLE SCHOOL

LEGEND Massachusetts School Building Authority (MSBA) **K-8 Guideline Range** (145–180 GSF per student)

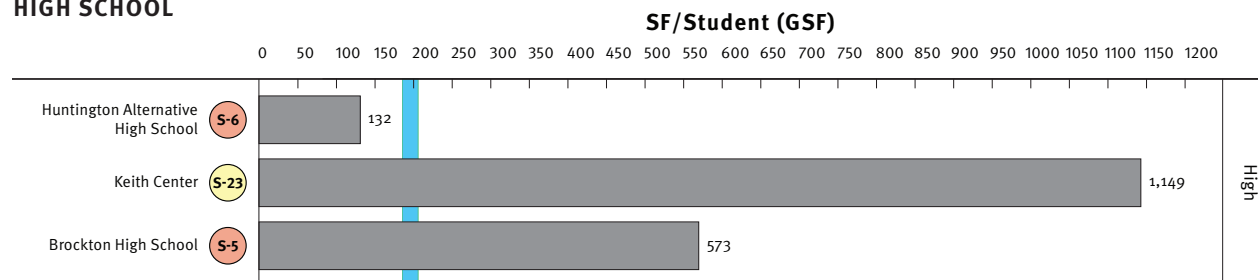
HIGH SCHOOL

LEGEND Massachusetts School Building Authority (MSBA) **High School Guideline Range** (185–205 GSF per student)

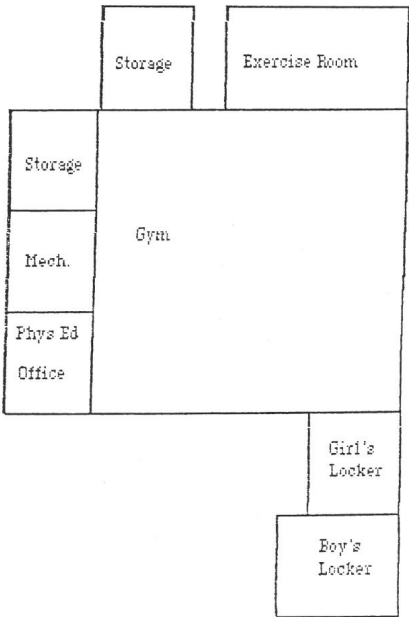
SUB-BASEMENT FLOOR PLAN

KEITH ELEMENTARY SCHOOL
SUB-BASEMENT FLOOR
